## ARCHITECT'S FIELD REPORT

119

PROJECT	<b>Eagle's Nest Townhouses</b> 11 Morning Glory Way & 31 Marcellina Lane Mt. Crested Butte, CO 81225	DATE	8/21/13
---------	--	------	---------

WORK OBSERVED	
Phase IV Construction	
TRADES PRESENT	
Holgate Construction Co.

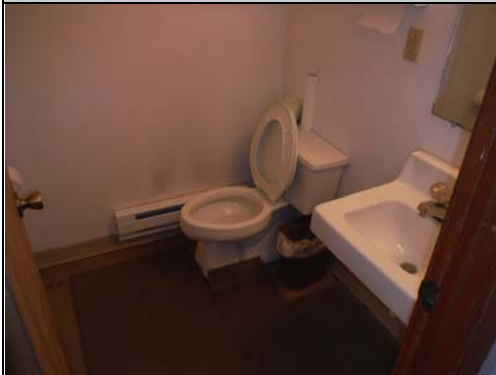
<p>8/21/13 – Photo 9 Lower Level Hot Tub Restroom</p> <p>Restroom is clean and in good order.</p>	Note

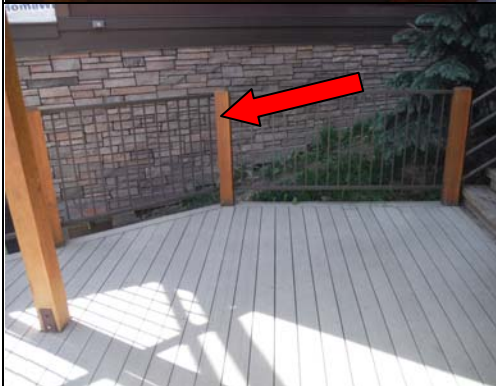
<p>8/21/13 – Photo 10 Lower Level Hot Tub Deck</p> <p>Record photo – the newel post at the red arrow is unsupported. The deck is sagging at this location.</p>	Note

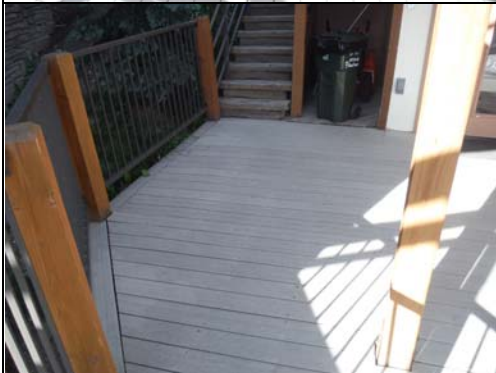
<p>8/21/13 – Photo 11 Lower Level Hot Tub Deck</p> <p>Existing deck boards at the newel post are starting to lift do to the settling.</p>	Note
